**INVESTIGATION**

**Bryson Crash**

## INVESTIGATION OF THE BRYSON CRASH

### EXPERT'S REPORT

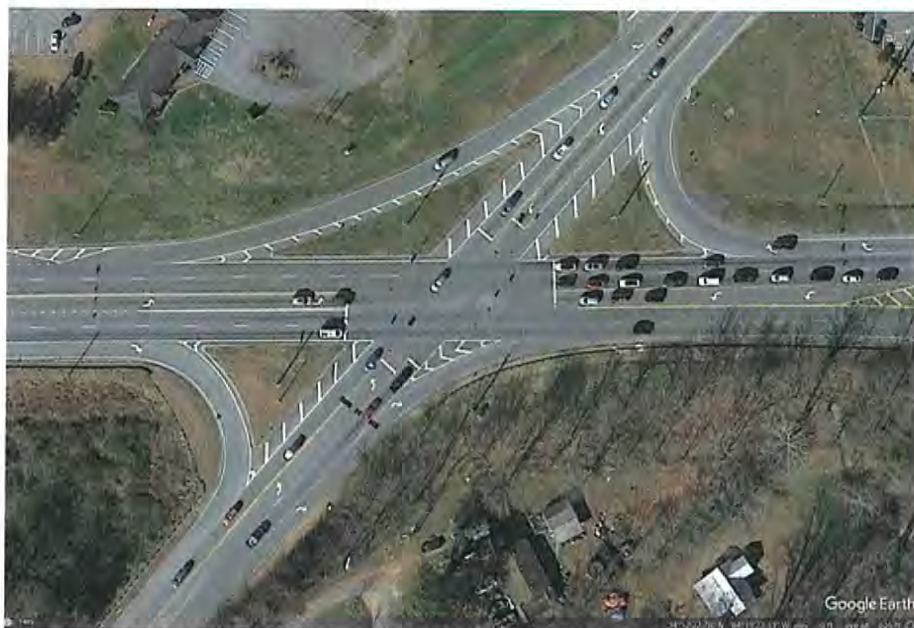
**Image 2: Google Earth image of the Crash Location**

The crash occurred on westbound GA2 at the intersection with GA5 (or Blue Ridge Drive). At the crash site, GA2 is predominantly a 4-lane, asphalt paved roadway that is generally orientated east-west. At the intersection, GA2 has turn lanes in both directions for access to GA5 resulting in 5 lanes locally. There is a double yellow line separating the westbound and eastbound lanes. The intersection has a traffic-control device (traffic light). In both directions there are partial width paved shoulders. At the time of the crash, it was dark but lighted and the road surface condition was dry. The speed limit for GA2 was posted at 45 mph. Image 2 shows a Google Earth image of the crash site as taken on 11/2021.

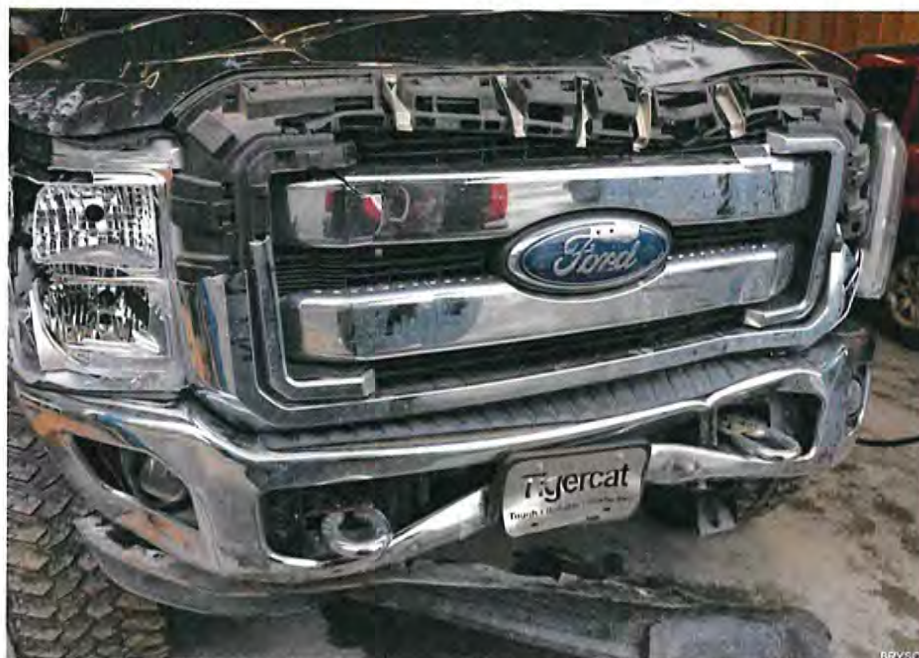
Image 3 – Ford F250 at Car Crafters, Towing Company Facility

Elliott's 2016 Ford F250 Super Duty King Ranch was a single rear wheel, crew cab pickup truck with four-wheel drive and a 6.7L diesel engine, VIN 1FT1FT7W2BT9GEC79140. The truck was modified by the fitment of a Rough Country lift kit which increased the ride height of the frame and body of the truck. The front-end damage sustained by the F250 can be seen in Image 3 which shows exterior trim damage to the lower valance and grille and front bumper and hood deformation.

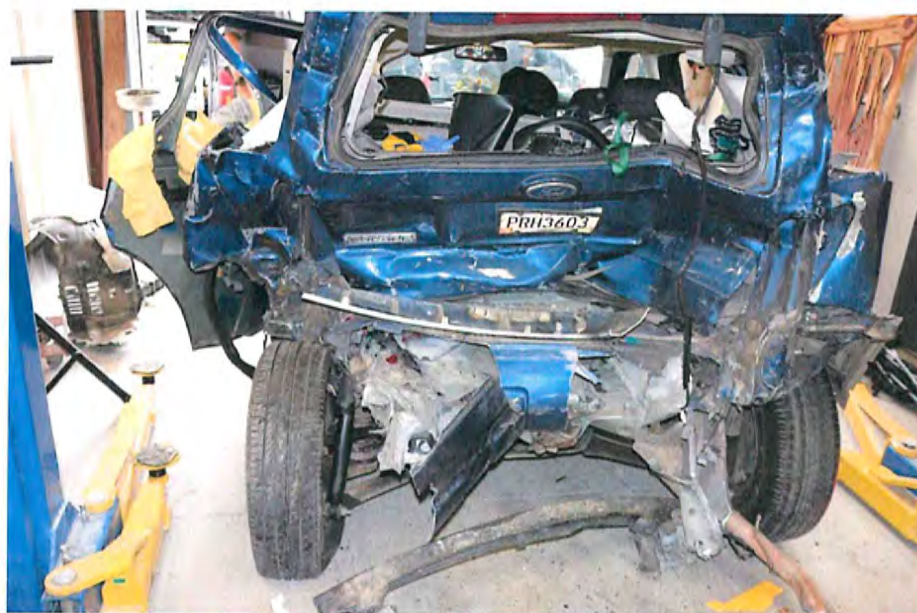
Image 4 – Ford Escape at Car Crafters, Towing Company Facility

Kelley's 2008 Ford Escape was a small 4-door SUV with two-wheel drive and a 3.0L gasoline engine, VIN 1FMCU03178KA77952. The rear end damage sustained by the Ford Escape can be seen in Image 4 which shows extensive structural deformation of the entire rear end of the vehicle and the rear bumper detached. Image 5 shows the rear passenger compartment with the rear child seat pushed forward into the back of the front driver's seat.

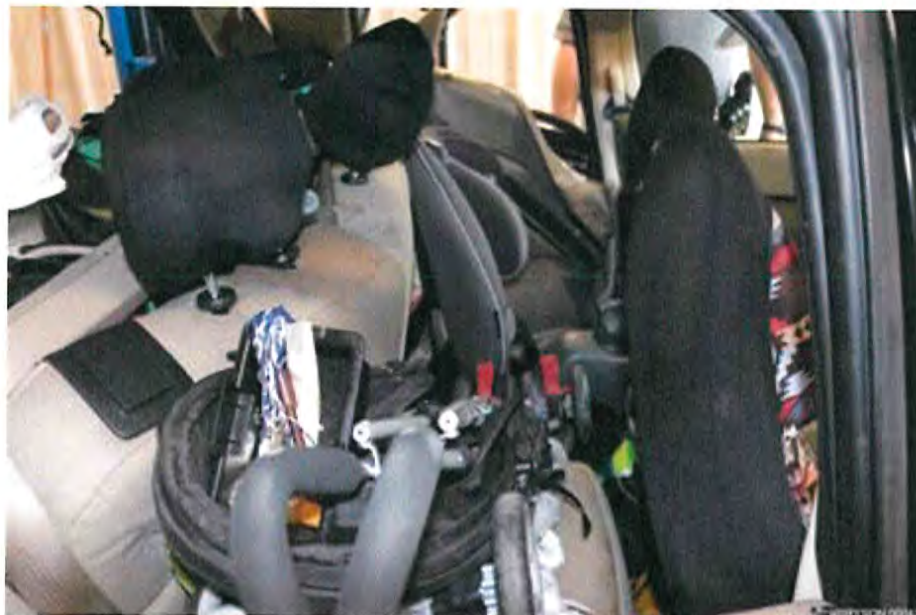
Image 5 – Ford Escape at Car Crafters, Towing Company Facility

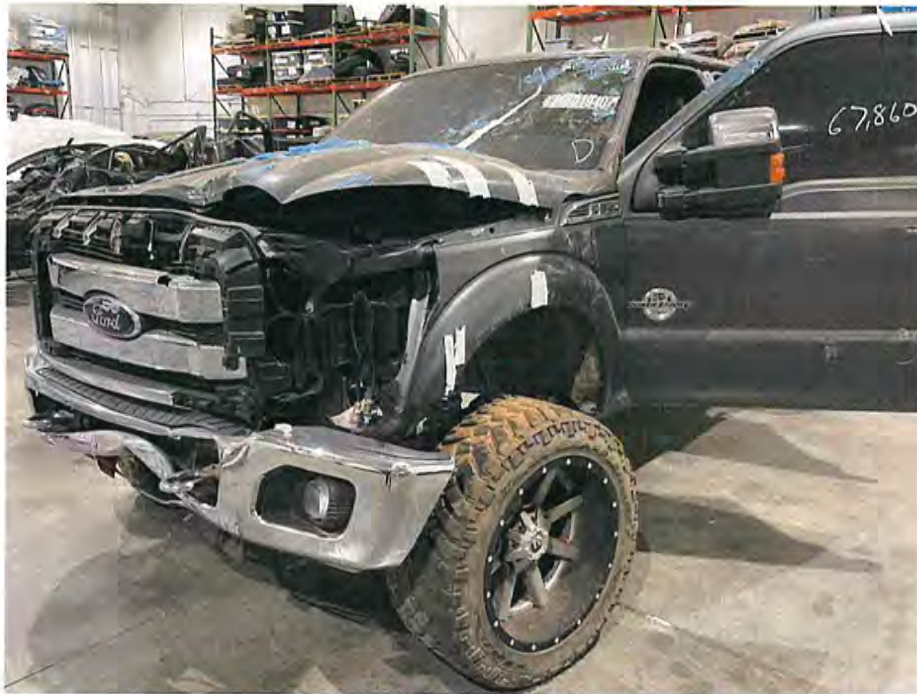
- Minimal deformation to the front end of the F250 (Image 6).
- Local deformation to the center of the bumper in a vertical direction. The presence of two Secondary Energy Absorbing Structure (SEAS) brackets showing minimal deformation or contact marks (Images 7 & 8).

Image 6 – F250 Front End Damage

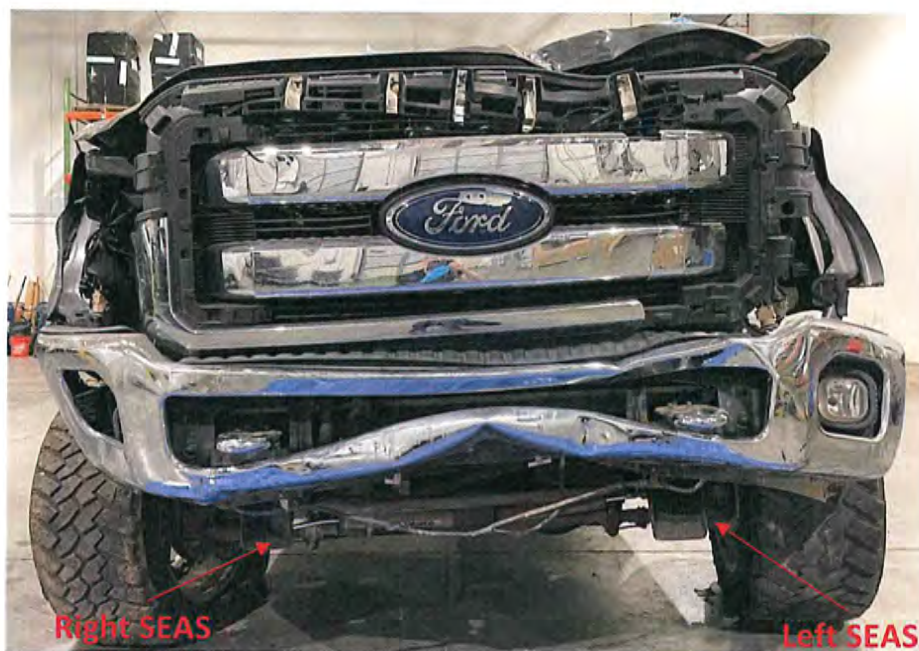
Image 7 – Bumper Damage & Secondary Energy Absorbing Structure (SEAS)

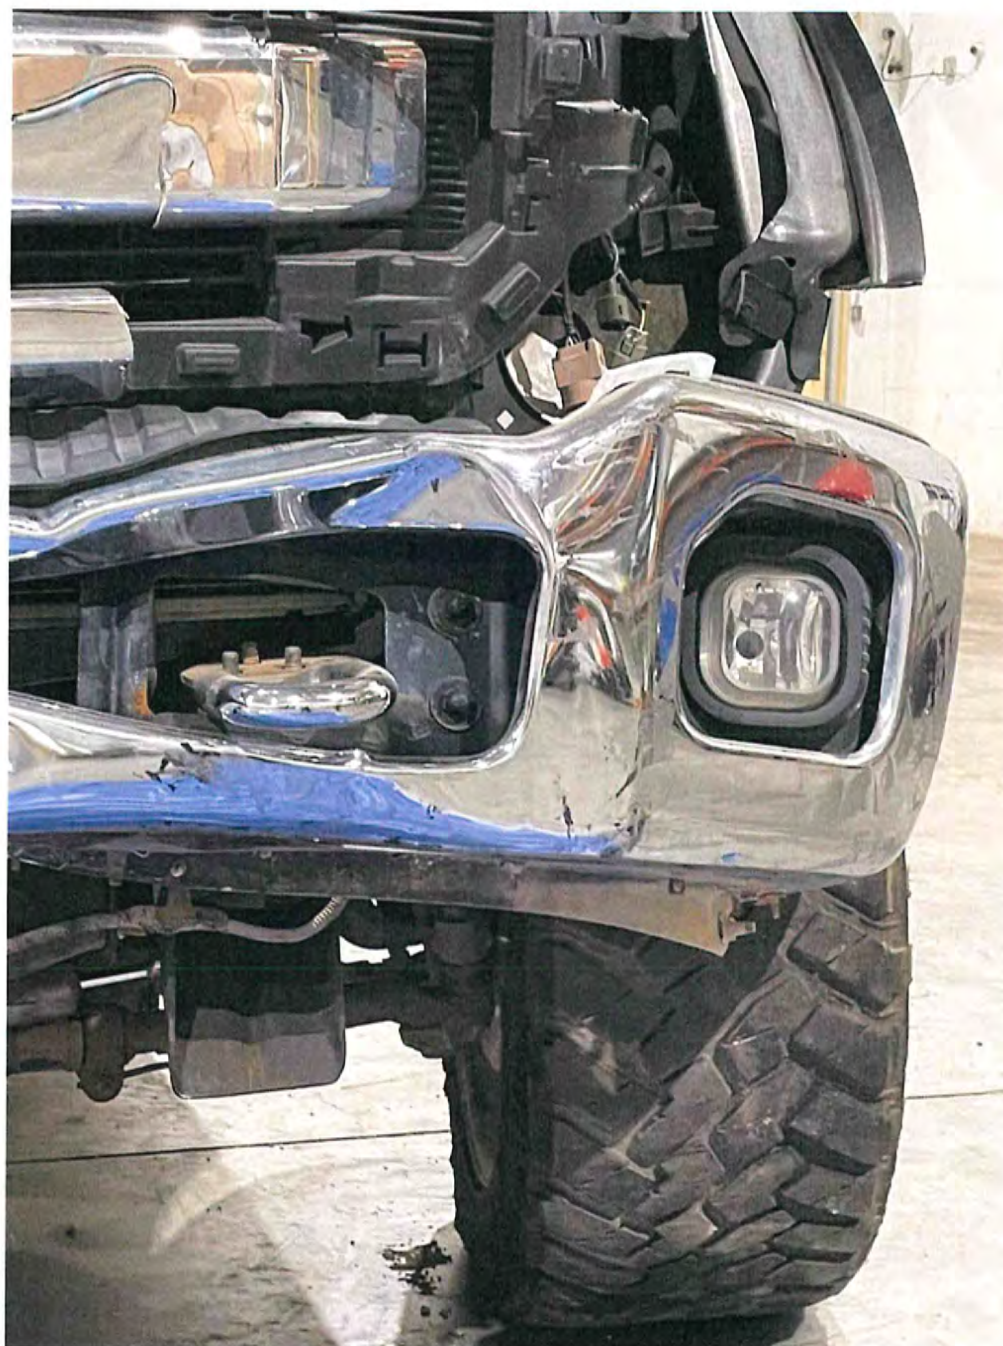
Image 8 – Bumper & Left SEAS

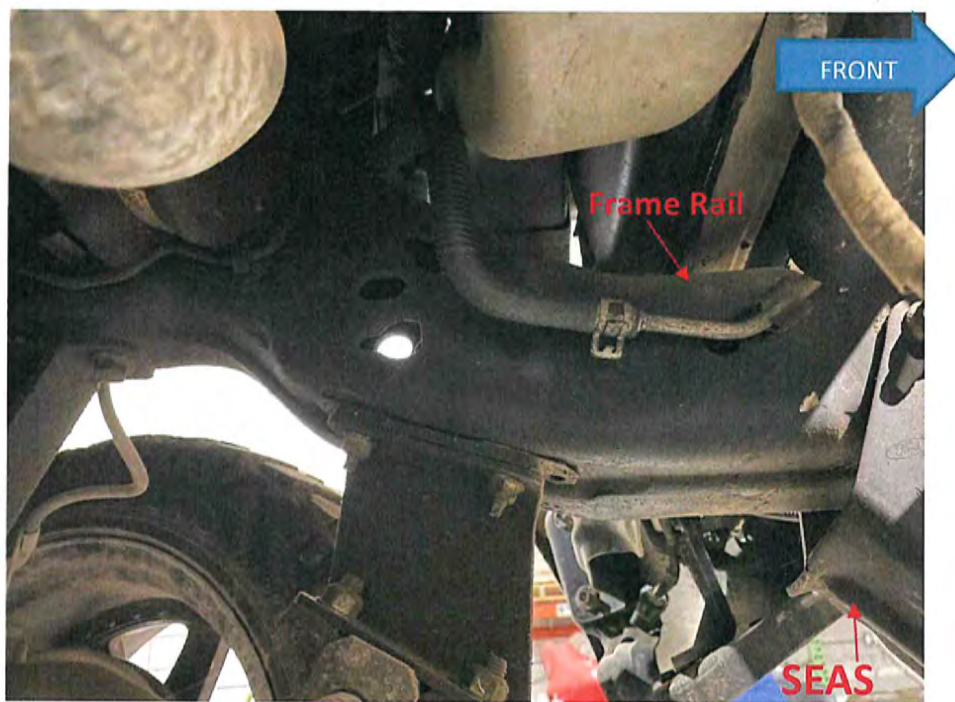
- Lack of crush or deformation to the Primary Energy Absorbing Structure (PEAS) or frame rail and no evidence of contact between the SEAS bracket and the frame (Image 9).
- Fitment of a Rough Country suspension lift kit to raise the vehicle's ride height (Image 10).

Image 9 – Left Front Frame Rail & SEAS

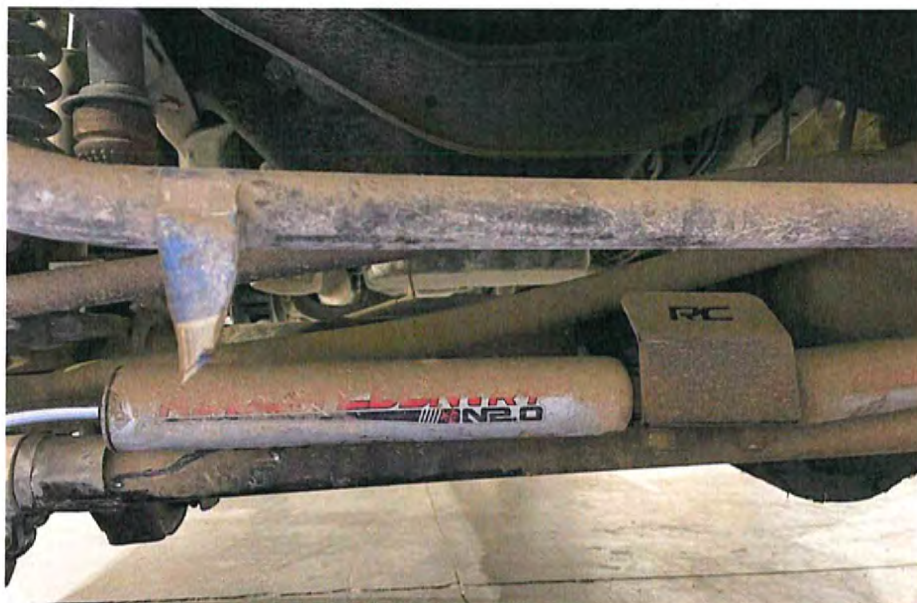
Image 10 – Rough Country Lift Kit Components

Elliott's F250 was fitted with RC item 567.20, a 4.5-inch lift kit. In the installation instructions, Rough Country states that the *"suspension system was developed for 35x12.5x17 tire"*. Elliott's F250 was fitted with 325/50R22 tires. These tires have an overall diameter of 34.8 inches and width of 12.8 inches – providing very similar overall dimensions to those specified by Rough Country.

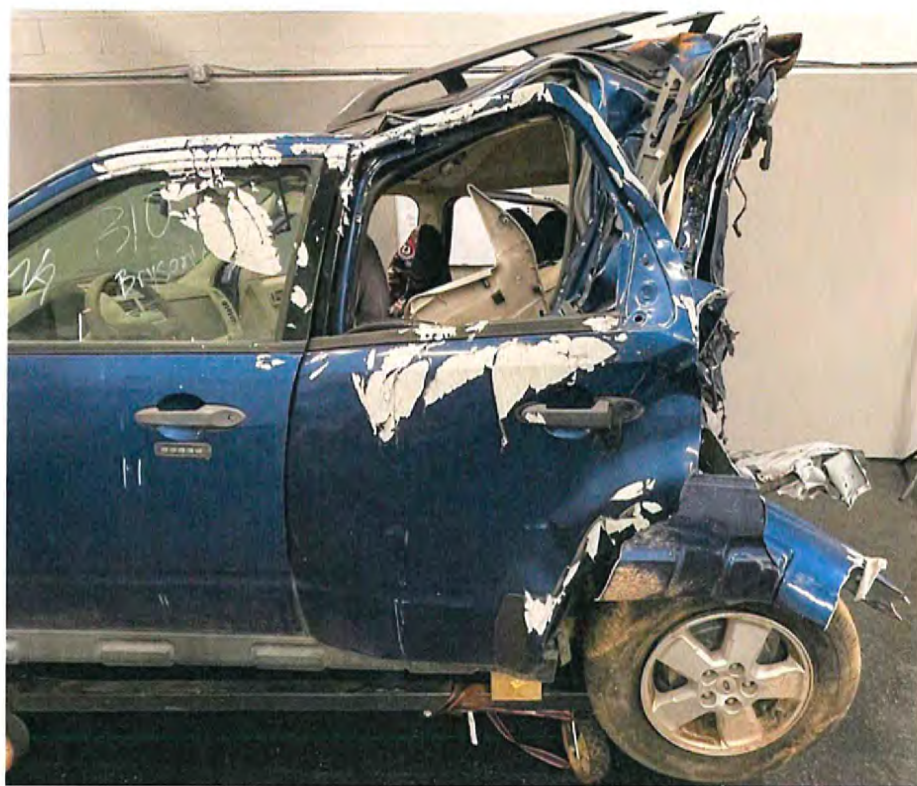
- The entire rear of the body has been significantly compressed with the D pillar collapsed onto the C pillar and both deformed forward in vehicle, exposing the rear wheels (Image 11).
- The lower rear body structure has been compressed forward in vehicle and both rear rails exposed with the floor panel and lower crossmember deformed forward in vehicle and peeled off from the rails (Images 12, 13 and 14). Neither rail exhibits significant axial collapse with local bending of the members only and the right rail bent downward. The rear bumper beam is detached. The liftgate has deformations either side of the rear window that are consistent with direct contact damage.
- The rear trunk space has been compressed longitudinally and the rear seats deformed forward in vehicle toward the front passenger seats reducing the second-row occupant space (Image 15).

**Image 11 – Ford Escape Rear Deformation**

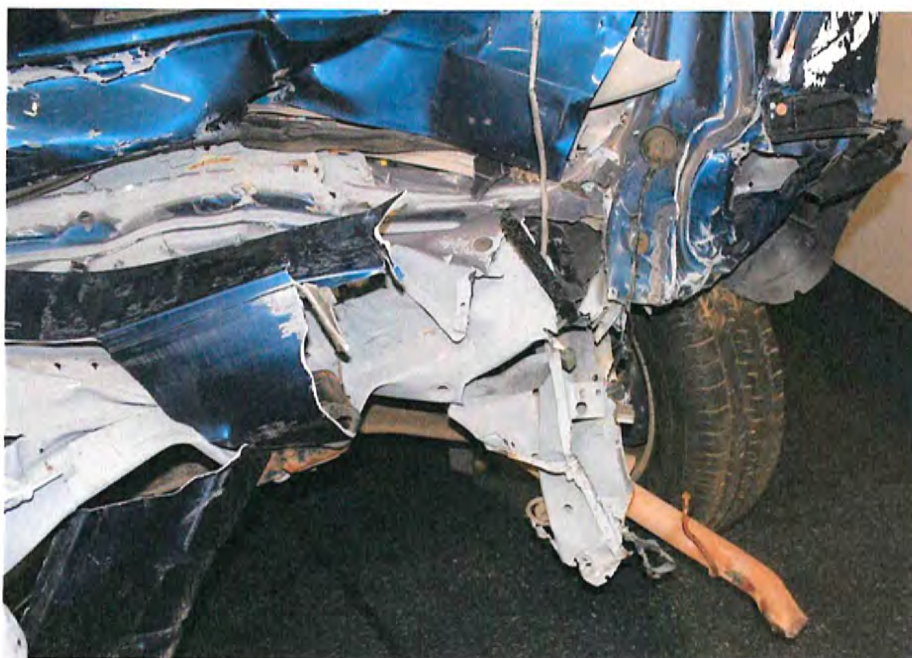
Image 13 – Ford Escape Right Rear Rail

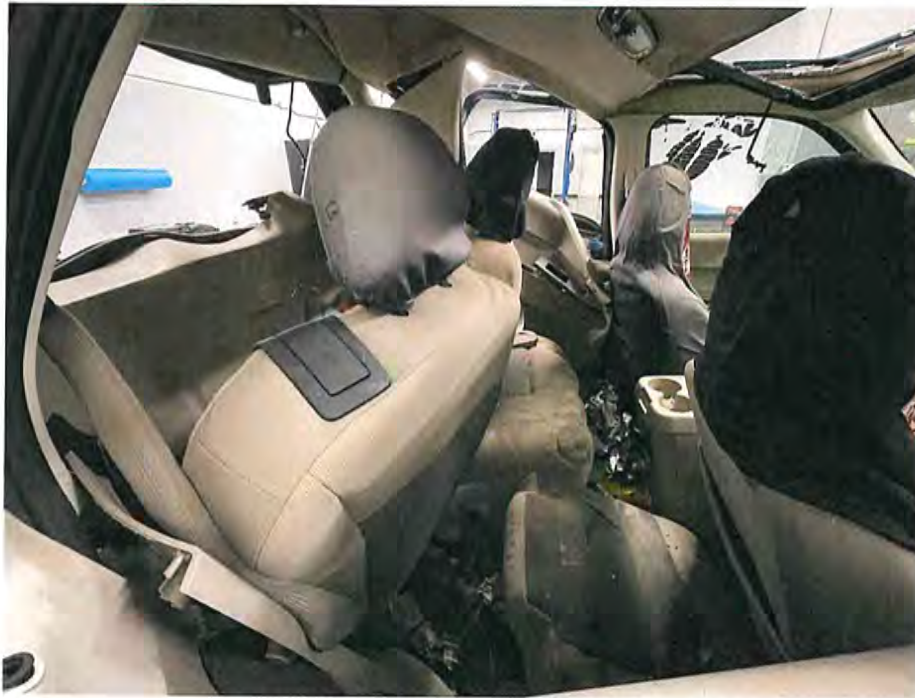
Image 15 – Ford Escape Rear Seats

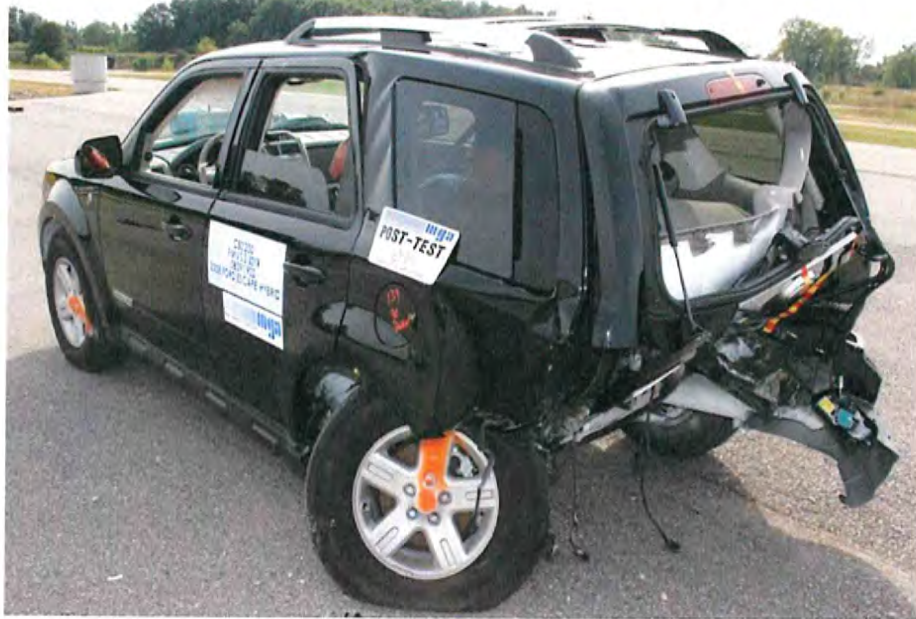
Image 20 – 2008 Ford Escape post FMVSS 301 Test

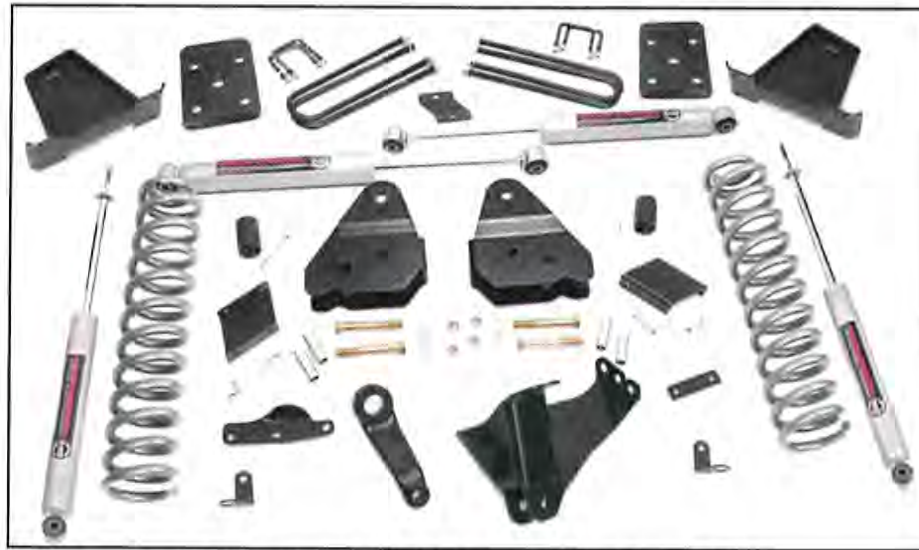
Rough Country (RC) specializes in selling parts and components to allow customization of standard vehicles including pickup trucks. RC currently produces lift kits designed to fit 2016 Ford F250s that provide increased ride heights from 3 to 6 inches. The RC 4.5 inch lift kit for a 2016 Ford Super Duty is shown in image 22. RC claims that their “easy-to-install lift kit raises the front of your vehicle to be equal height with the rear for a leveled, better-than-stock look that gives an improved ride height and more aggressive appearance”. RC claims that their kits are designed to “keep everything at optimum angles for a factory-like ride, even after lifting”. There is nothing in the kits that enables a lifted truck to maintain compliance with the EVC, nor does RC explain or state (on their website or in the installation manuals) that the fitment of the kit could render the existing truck’s safety features ineffective or less effective. RC only directs customers to check local state compliance via a website.

Image 22 – 4.5 inch Lift Kit for a 2016 Ford Super Duty

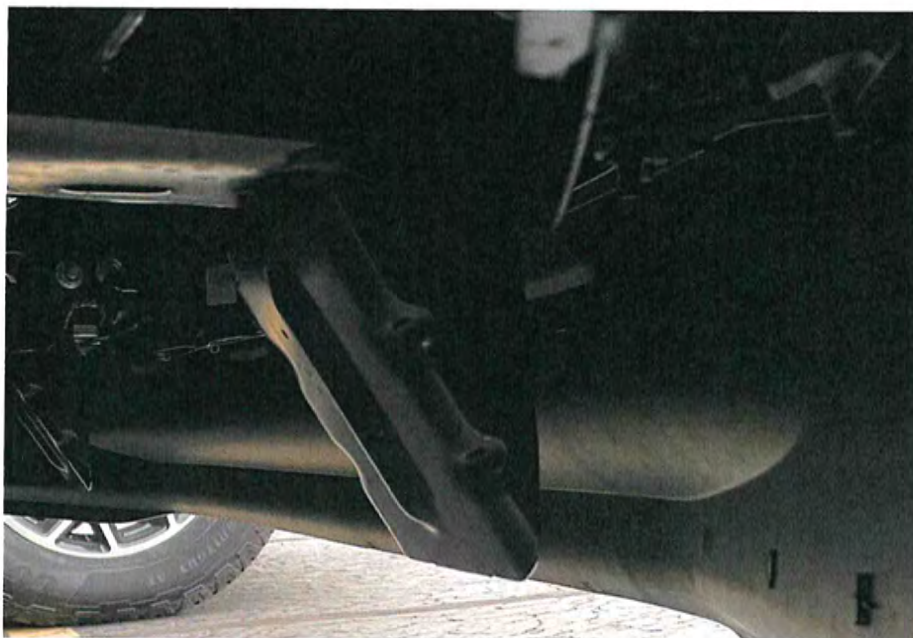
Image 25 – 2022 Ford F350 SEAS Bracket & Frame Rail

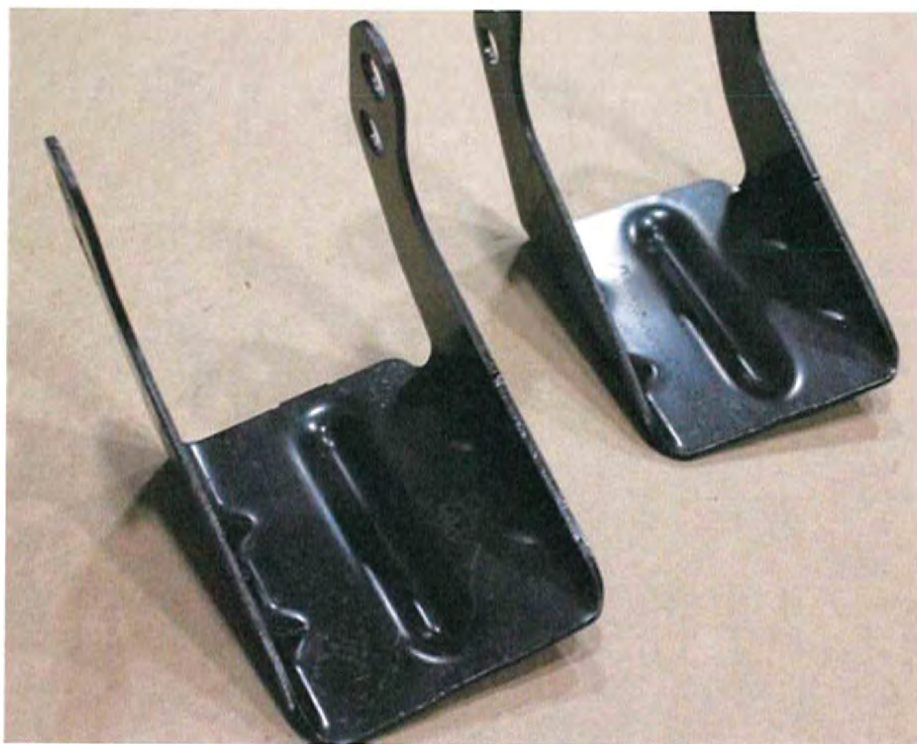
Image 26 – 2016 Ford F250 SEAS Brackets

The SEAS brackets fitted to the 2016 Ford F250 (image 26) are relatively simple, stamped U-shaped brackets that are bolted to the main frame rail in two locations each. Each bracket costs about \$25 when

purchased from a Ford dealer as a replacement part. Rough Country could have developed components to maintain vehicle compatibility and could have advised customers to fit the new components when using a lifted vehicle on public roadways. Rough Country has the capability to design and produce new versions of the U-shaped brackets with modified geometry to account for the ride height increase of the lift kit and to ensure it satisfied the 16 inch height and 100 kN load requirement of the EVC agreement. The SEAS brackets are bolted to the frame rail and so removing and replacing them with new components is straight forward and consistent with how the lift kit is installed. The alternative design of new SEAS brackets would not affect the utility of the vehicle on-road and could be easily removed for off-road use, if necessary.
